Manhole Inspection Summary

Manhole # S39S__010MH

Insp Date: **3/13/08 12:25 PM**

Location Address: **601 e.clement st**

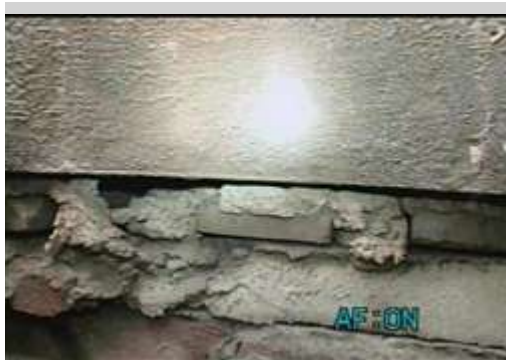
Defect 1

Condition: ☐ Sound ☒ **Cracked** ☐ Root Intrusion ☒ **Loose Brick** ☒ **Deteriorated**

Loose brick_chimney adjustment

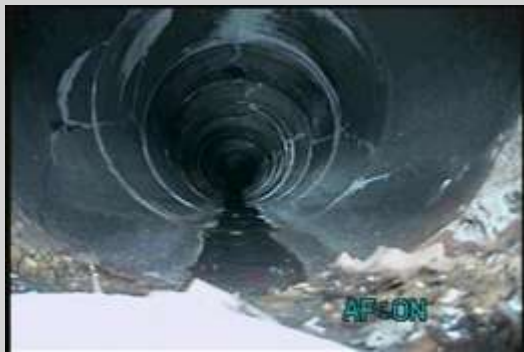
12 O'Clock Outflow

24 in. Circular Gravity Sewer
Pipe Out @ 12 O'Clock

Invert Depth: 8.40 (ft.) Flow Characteristics: **Slow**

Deposits: ☒ None ☐ Mud ☐ Sludge ☐ Debris ☐ Grease

Infiltration: **None** Pipe Seal Cond: **Unknown**

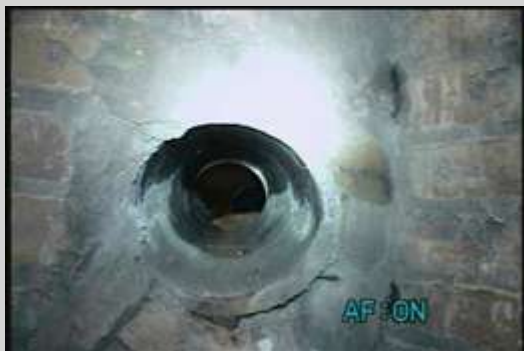
5 O'Clock Inflow

8 in. Circular Gravity Sewer
Pipe In @ 5 O'Clock

Invert Depth: 5.33 (ft.) Flow Characteristics: **None**

Deposits: ☒ None ☐ Mud ☐ Sludge ☐ Debris ☐ Grease

Infiltration: **None** Pipe Seal Cond: **Unknown**

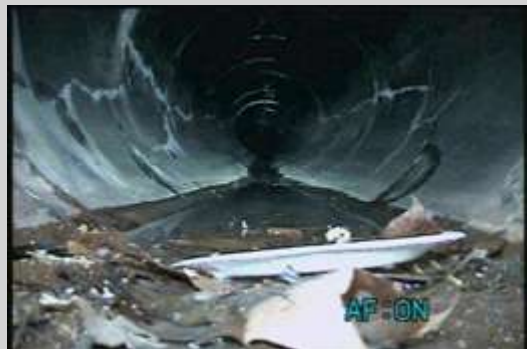
6 O'Clock Inflow

24 in. Circular Gravity Sewer
Pipe In @ 6 O'Clock

Invert Depth: **8.30** (ft.) Flow Characteristics: **Slow**

Deposits: ☒ None ☐ Mud ☐ Sludge ☐ Debris ☐ Grease

Infiltration: **None** Pipe Seal Cond: **Unknown**
